NASA Technical Memorandum 102371

Characterization of Failure Processes in Tungsten Copper Composites Under Fatigue Loading Conditions

Yong-Suk Kim, Michael J. Verrilli, and Timothy P. Gabb
Lewis Research Center
Cleveland, Ohio

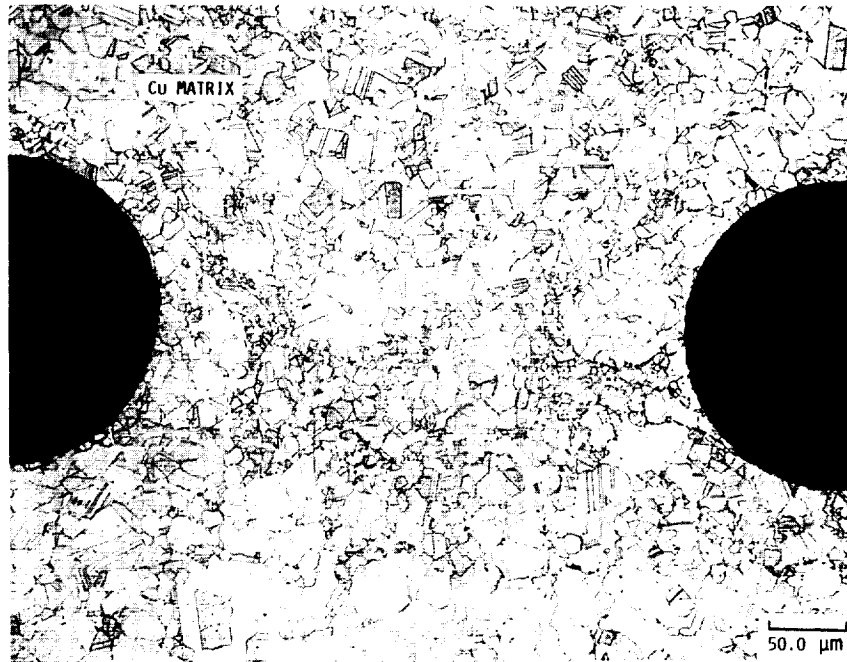
The microstructure of the as-received composite was examined with an optical microscope (fig. 2). Figure 2 shows both the Cu matrix and the periodically arranged W fibers. The interspacing between fibers is not regular, and the matrix grain size varies with locations. Figure 3 is an enlarged micrograph of the as-received composite. The uneven grain size distribution in the Cu matrix is well displayed. The grain sizes are in the range of 8 to 15 μm . Usually, finer grains are observed near the fiber, whereas large grains occur between fibers. No interface reaction products were observed, which is consistent with other studies (refs. 1 to 10).

FIGURE 3. - MAGNIFIED MICROGRAPH OF AN AS RECEIVED W/Cu COMPOSITE. NOTE THE UNEVEN DISTRIBUTION OF GRAIN SIZES IN THE Cu MATRIX.

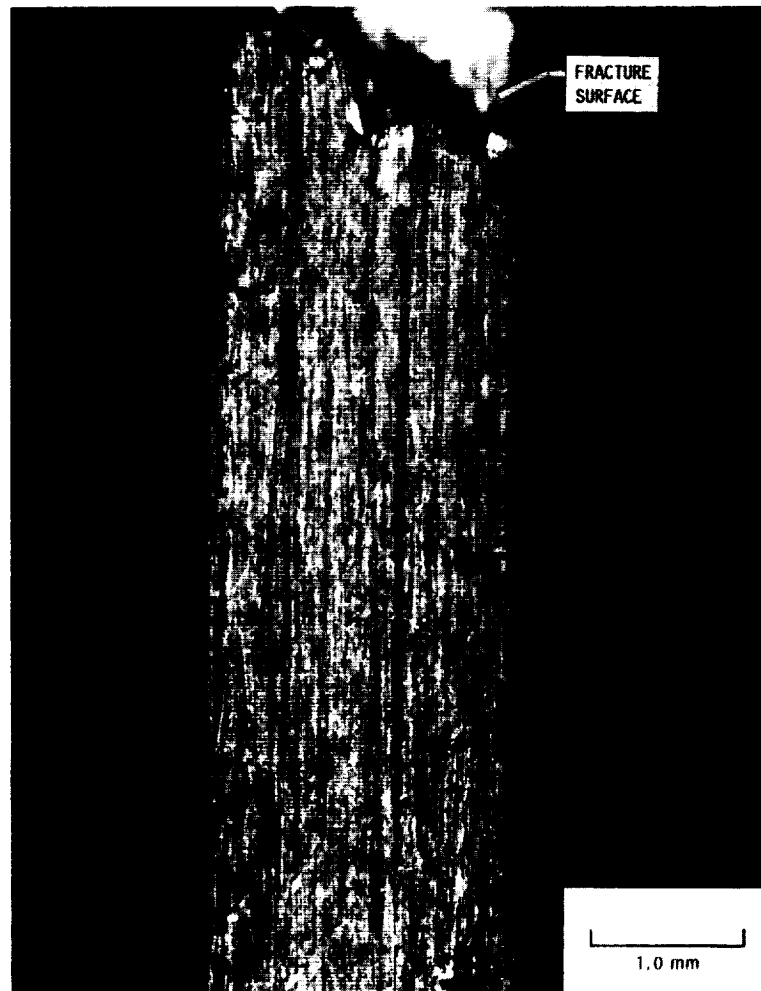
The fatigue specimens tested to failure at 533 K show many small secondary edge cracks along the specimen edge, far from the dominant crack which led to failure. Figure 5 is a low-magnification micrograph of the side of a fractured specimen at 533 K. The fracture surface is indicated in the figure. As figure 5 shows, these side cracks were spaced at fairly regular intervals. Most

of the side cracks only extended to the first row of fibers and then stopped growing. In contrast, the specimens tested at 833 K did not develop as many secondary-edge cracks nor did they exhibit as much accumulated plastic strain.

FIGURE 5. - A SIDE VIEW OF A FATIGUE SPECIMEN FRACTURED AT 533 K. THE MAXIMUM APPLIED STRESS IS 280 MPa, AND THE SPECIMEN FAILED AFTER 933 CYCLES.

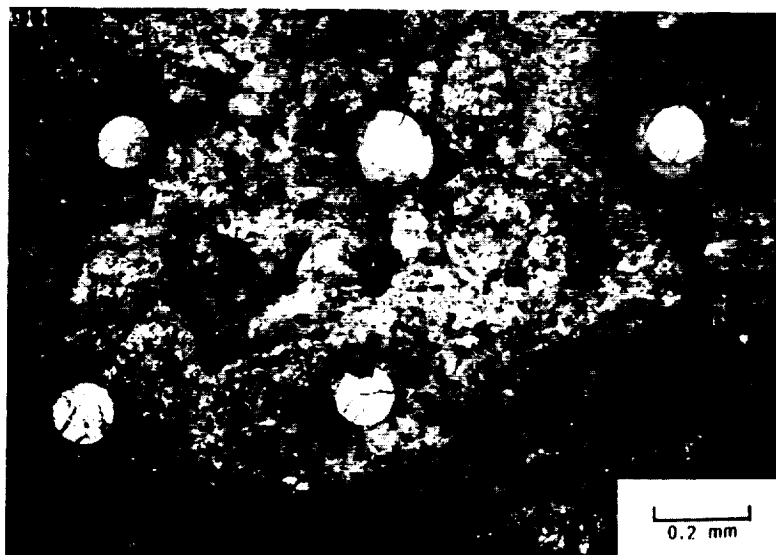
Figure 8 shows the fracture surface of a fatigue specimen tested at 533 K. The composite experienced ductile failure in both constituents. The fiber failure indicates large inelastic deformation that produced necking. The matrix failed in fatigue by a predominantly intergranular mode, whereas final tensile overload failure occurred by a predominantly transgranular mode.

FIGURE 8. - SEM MICROGRAPH (BACK SCATTERED MODE) OF THE FATIGUE FRACTURE SURFACE OF A SPECIMEN TESTED AT 533 K WITH A MAXIMUM STRESS OF 240 MPa. BOTH MATRIX AND FIBER SHOW A DUCTILE FAILURE.

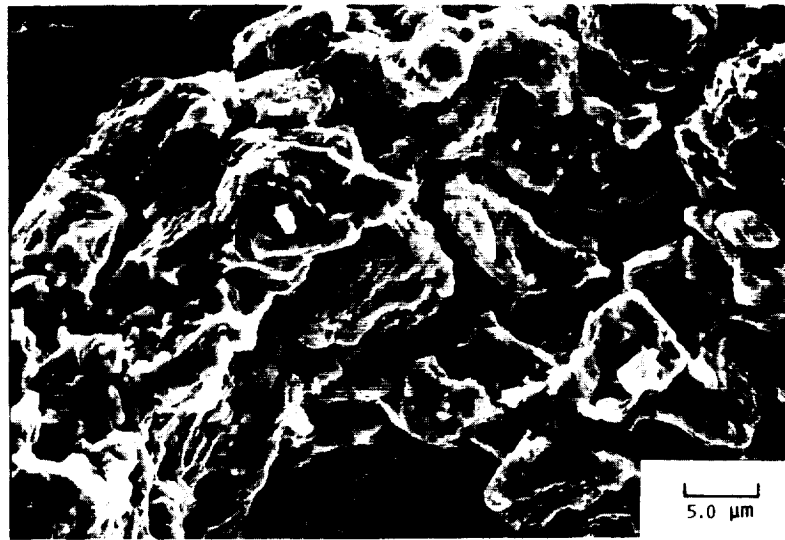
Figure 9 is a magnified view of the failed matrix tested at 533 K. Figure 9(a) is a fractograph of an intergranular fatigue failure region, and figure 9(b) is a fractograph of a transgranular tensile failure region. Figure 9(a) clearly shows the intergranular failure mode, along with a very irregular grain size. No fatigue striation marks are observed, but the cracks and cavities along the grain boundaries are revealed. Figure 9(b) reveals a typical ductile overload failure region. In these specimens, the intergranularly fractured regions are mostly confined to the outer surface of the specimen and to the matrix surrounding the fiber. The ductile overload fracture normally occurs in the middle of the specimen, in the midregion between fibers.

(a) INTERGRANULAR FAILURE REGION.

FIGURE 9. - MAGNIFIED SEM FRACTOGRAPHS OF THE Cu MATRIX FAILED AT 533 K.

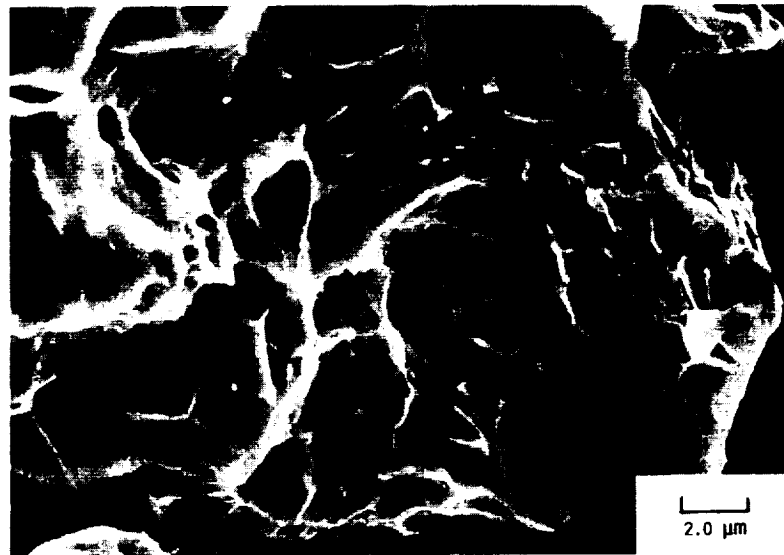
(b) TRANSGRANULAR, DUCTILE OVERLOAD FAILURE REGION.

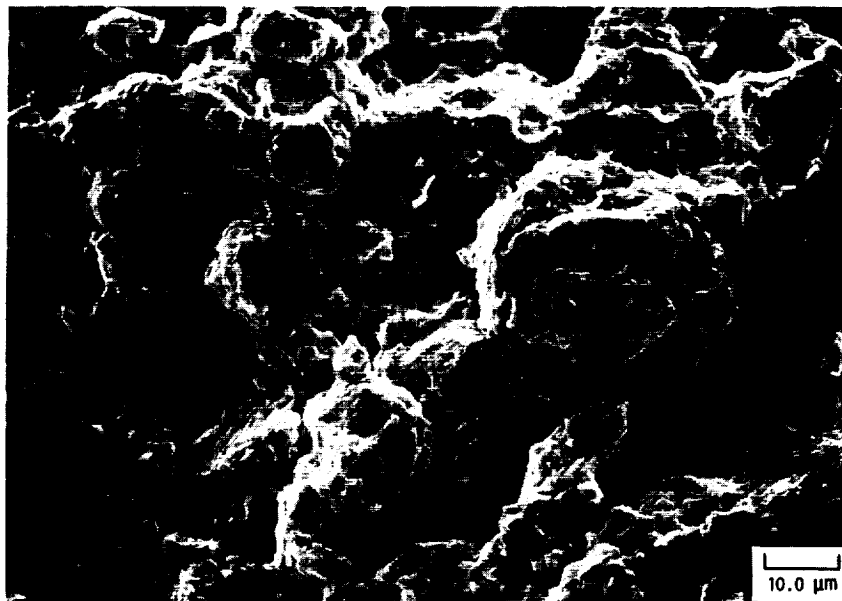
The fractography of specimens tested at 833 K is different from that at 533 K. Most of the fracture surface exhibits an intergranular failure mode as shown in figure 10. Not much ductile overload failure is observed, even in the middle of the specimen. The magnified view of the intergranularly fractured surface shows more clearly formed grain boundary cavities than those for the 533 K tests.

FIGURE 10. - SEM MICROGRAPHS OF A FATIGUE FRACTURE SURFACE FOR A SPECIMEN TESTED AT 833 K SHOWING AN INCREASED INTERGRANULAR FAILURE MODE IN THE CU MATRIX.

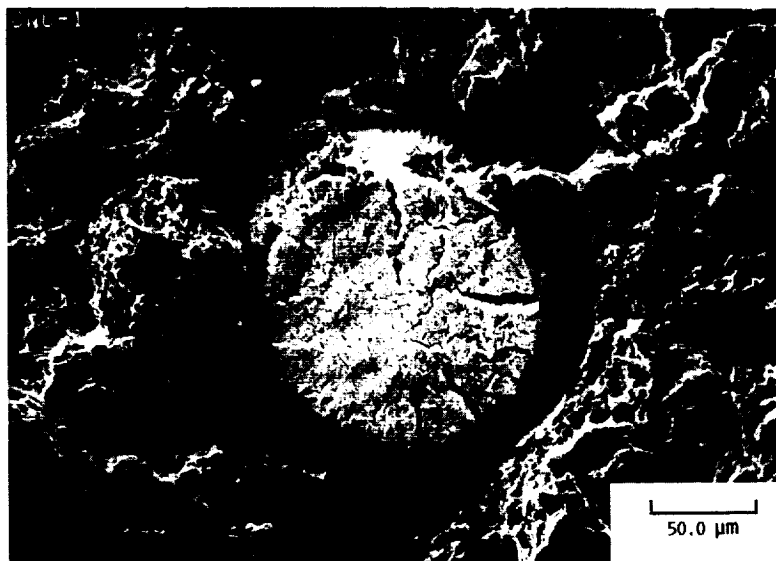
To compare the fractography under different test conditions, we also examined the fracture surface of a creep specimen ruptured under a static load of 240 MPa at 533 K (fig. 11). Compared with the fatigue specimen tested at the same temperature, the matrix of the creep-ruptured specimen shows more predominant intergranular failure throughout the specimen cross section. However the fracture nature of the tungsten fiber varies little from the fatigue specimen: the fiber exhibits large plastic deformation.

FIGURE 11. - SURFACE OF A CREEP-RUPTURE SPECIMEN TESTED UNDER A STATIC LOAD OF 240 MPa AT 533 K IN VACUUM. A PREDOMINANT INTERGRANULAR FAILURE MODE IS OBSERVED IN THE MATRIX.

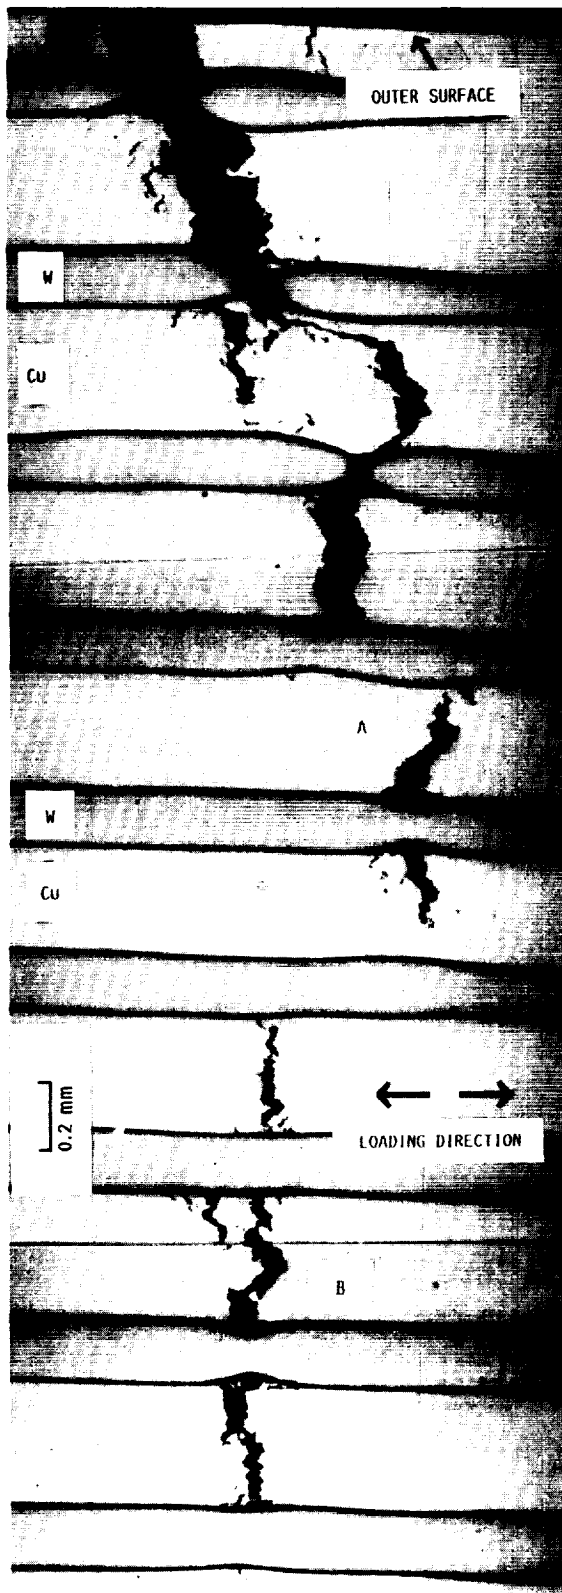
Figure 12 is an optical micrograph of a longitudinal section near the fracture surface of a specimen fatigue fractured at 533 K. The section shows one layer of fibers among the four plies which comprise the composite. Even though this section is not of the dominant crack, the secondary cracks shown in figure 12 can be assumed to be similar to those that occurred along the dominant fracture plane. The figure shows matrix cracks that are perpendicular to the loading direction and shows the fractured fibers. The cracks shown in figure 12 may have been widened during final failure of the specimen. However they still do provide information for crack initiation and propagation processes. The large crack opening displacement at the left side of the specimen indicates that the dominant crack initiated at the side of the specimen and propagated into the inner portion of the specimen.

Besides surface cracks, some cracks were observed to originate internally in the Cu matrix. The crack marked "B" in the figure is one of such cracks. The crack is independent from the propagating approaching crack, marked "A", and apparently it initiated separately. Subsequent examinations of underlying layers confirmed that these cracks were not connected.

The fibers are broken, forming nicely shaped necks at widely opened Cu matrix cracks, and fiber failure is not limited to the crack front. The fibers seem to break after the surrounding matrix degrades. The deformation of the fiber appears to be very localized, since the necking is confined within a very narrow region between the mating surfaces of the propagating crack.

FIGURE 12. - LONGITUDINAL SECTION OF A FATIGUE SPECIMEN FRACTURED AT 533 K; MAXIMUM STRESS, 260 MPa; MINIMUM LOAD/MAXIMUM LOAD (R RATIO), 0.04. A, CRACK PROPAGATING FROM SPECIMEN SURFACE TO INTERIOR; B, INTERNALLY ORIGINATING CRACK.

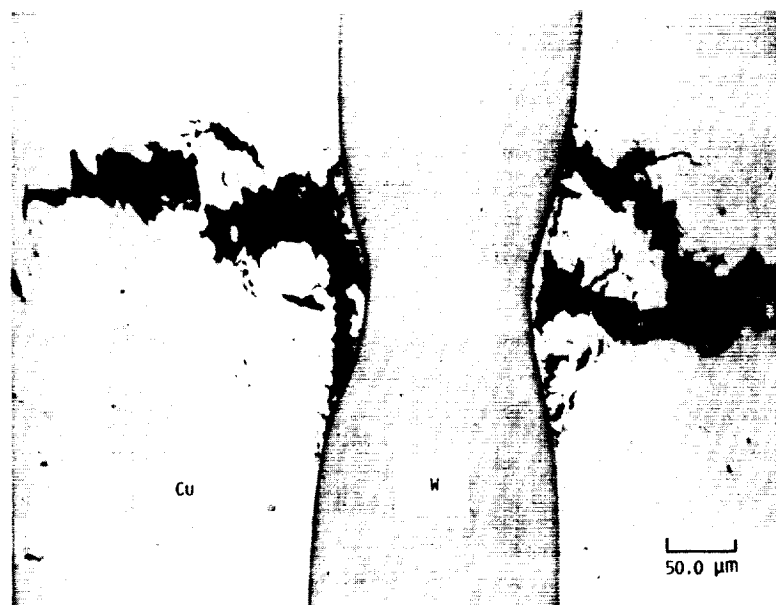
FIGURE 14. - OPTICAL MICROGRAPH SHOWING NECKING OF A TUNGSTEN FIBER AFTER FATIGUE AT 533 K.

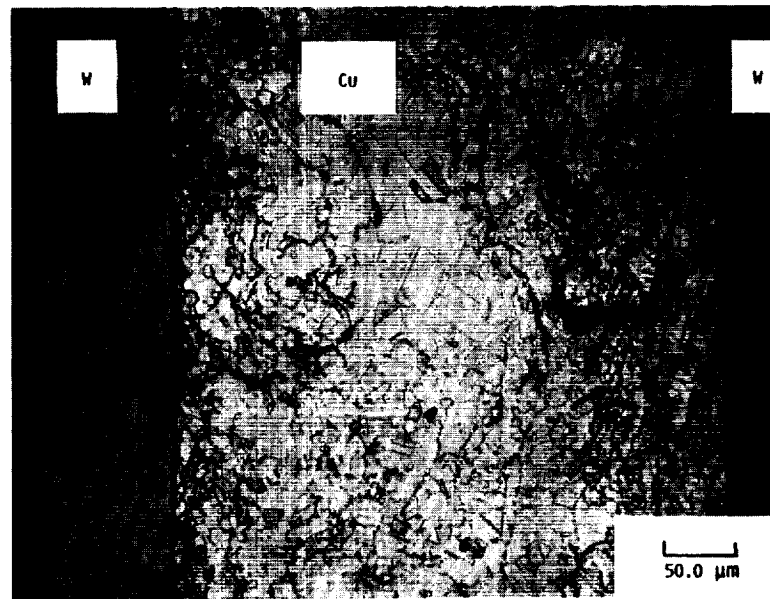
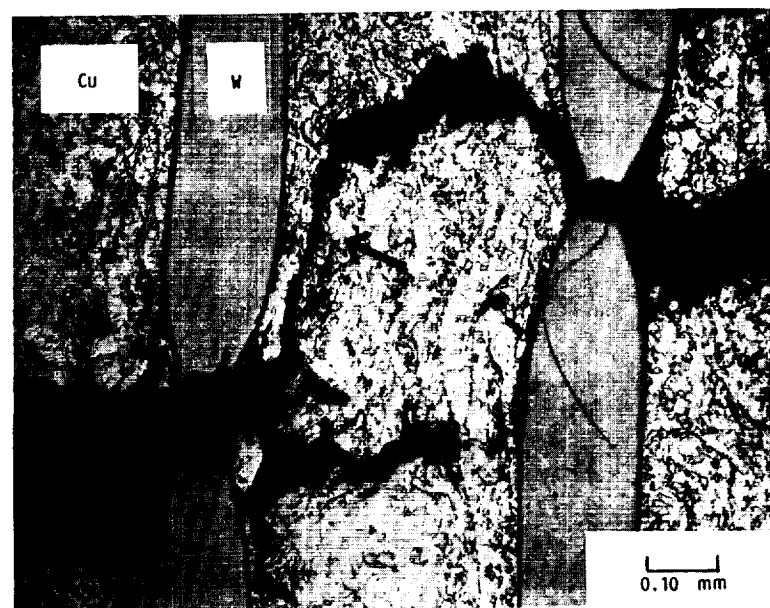
The fatigue failure of the composite strongly depends on the grain size of the matrix. Figure 15 shows how the grain size affects the failure of the composite. The small-grain region has more cavities than the large-grain region, and cracks propagate more readily through the small-grain region. Currently, the authors believe that the grain size effect is related to grain boundary sliding (GBS). Together with slip and diffusion, GBS is a well-known deformation process in fine-grain materials. Luthy et al. (ref. 15) modified the Ashby Deformation Map by including GBS as another deformation mechanism. They showed that GBS plays an important role at all temperatures in the deformation of a fine-grain material. Even though the composite specimen experienced only tension-tension cyclic loading, the Cu matrix is believed to experience compressive stresses during the unloading cycle because of the repeated plasticity and cyclic relaxation of the tensile matrix stresses. Repeated tension and compression inside the Cu matrix results in cyclic shear stresses that promote grain boundary sliding. It has also been reported that a wedge-type cavitation prevails when grain boundary sliding is a major deformation mode (ref. 16). Some SEM pictures and optical micrographs from an early stage of cavitation in an interrupted test specimen show more wedge-type cavitation than r-type cavitation. This observation again supports the view that the composite matrix experiences grain boundary sliding under the given loading conditions and temperatures. A specimen with a large-grain matrix could have a prolonged life under the same loading conditions because of the decreased chance of grain boundary sliding. Testing and analyses to further confirm these findings are currently underway.

(a) CRACKS INITIATE AT FINE-GRAINED REGION.

(b) CRACKS PROPAGATE THROUGH FINE-GRAINED REGION.

FIGURE 15. - LONGITUDINAL SECTION OF A SPECIMEN FATIGUE FRACTURED AT 533 K SHOWING THE EFFECT OF GRAIN SIZE ON CRACK INITIATION AND PROPAGATION.
